A Guide to Corrosion Under Insulation Management

Written by Phillip E. Prueter

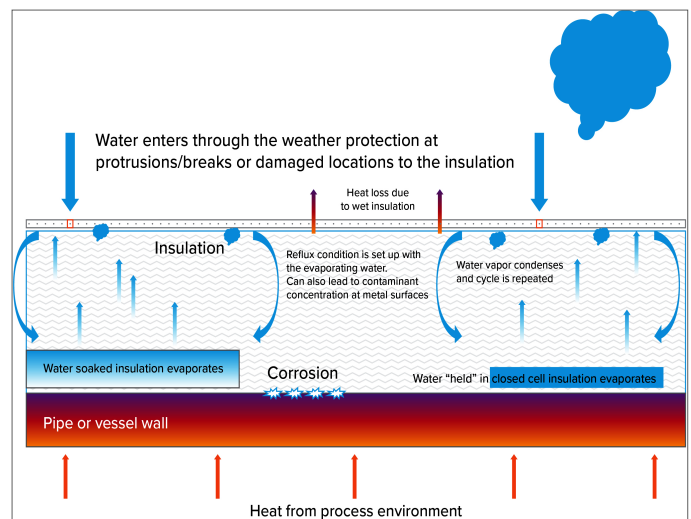
Figure 2. Schematic of CUI Mechanism Beneath Hot Thermal Insulation [2].

In its simplest form, the electrolyte is oxygenated water, which may contain contaminants that can accelerate the corrosion rate. **Figure 2** shows a practical application of the

CUI electrochemical reaction on a thermally insulated pipe or pressure vessel. In this figure, after water penetrates the insulation, it is either absorbed or trapped. Once the water contacts the hot steel surface, it evaporates. Then, the evaporated water vapor moves through the insulation towards the colder external barrier or jacket where condensation occurs. This condensed water then migrates back through the insulation towards the hot metal surface, and the process repeats itself. Additionally, contaminants can end up being concentrated on the steel surface due to the cyclic nature of the evaporation and condensation process. These contaminants can degrade external coatings on the steel and eventually, CUI damage occurs. This cycle can also result in damaged insulation which may reduce the effectiveness of the insulation system. Intuitively, insulation systems that hold the least amount of water and that dry out the fastest are generally the most resistant to CUI damage. The integrity of the insulation jacketing and an intact external coating on the steel surface are also crucial factors that influence CUI susceptibility.

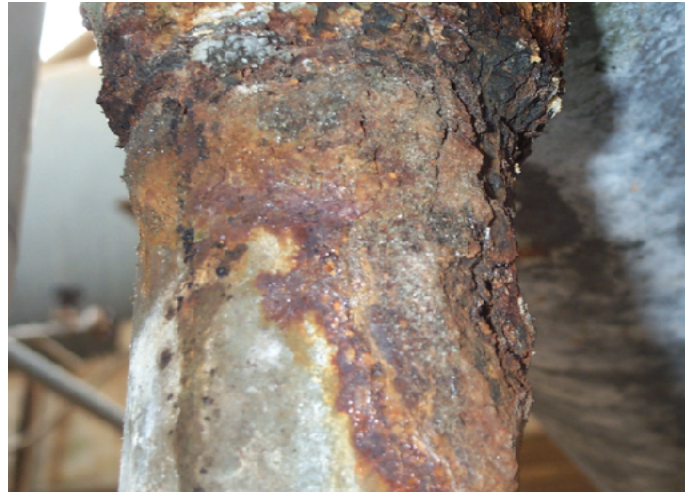
Figure 3. Close-up of CUI (Localized Corrosion) of a Piping Tee after Insulation Removal [3].

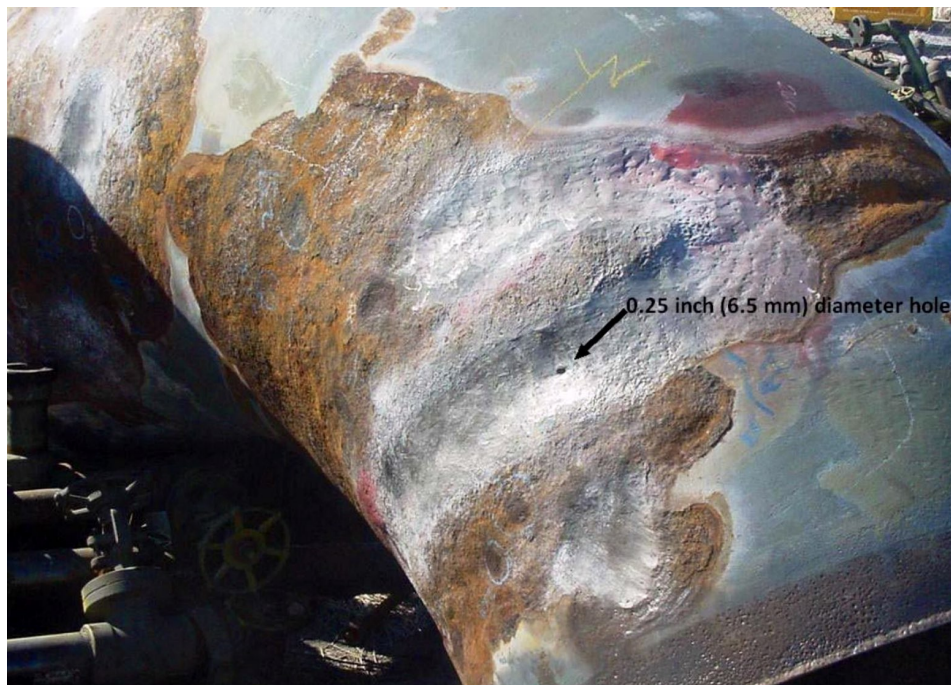
Figure 8. Example of a Small Diameter Hole (Pinhole Leak) in a Carbon Steel Pipe Due to CUI [4].

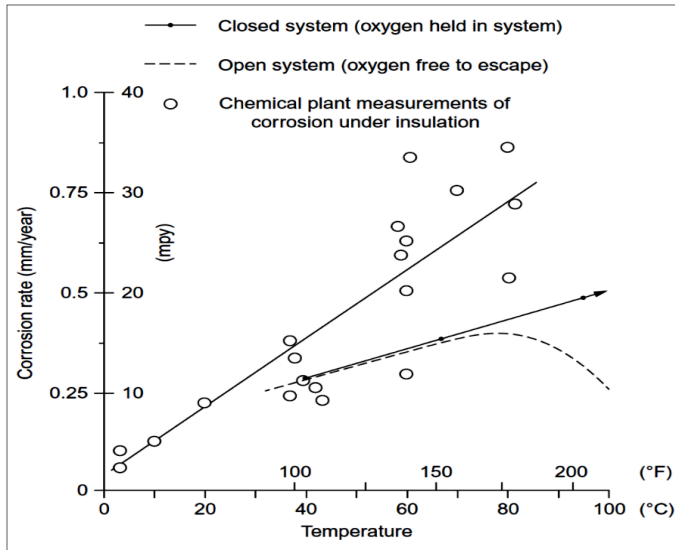
Figure 13. Predicted CUI Corrosion Rates for Carbon Steel as a Function of Service Temperature^[2].

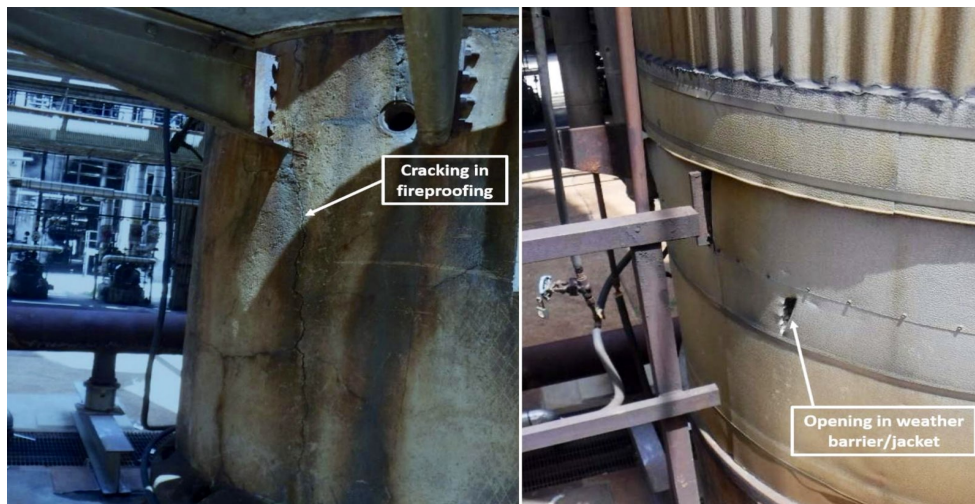
Figure 14. Examples of Degrading Fireproofing on a Support Skirt (Left) and Damaged Weather Barrier/Jacketing on a Vertical Pressure Vessel (Right).

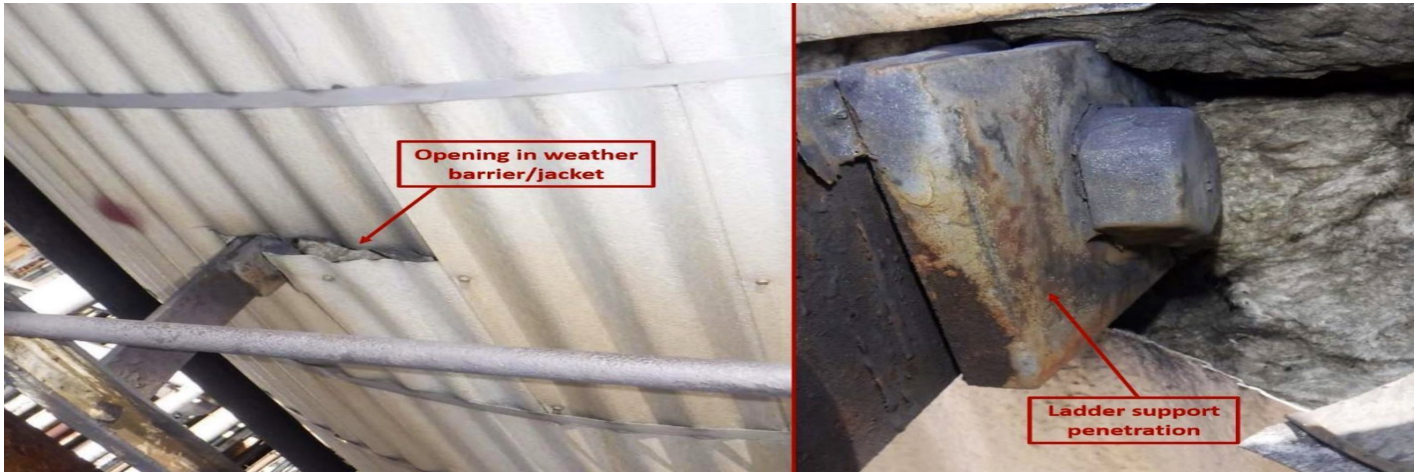
Figure 15. Examples of Unsealed Weather Barrier/Jacketing (Left) and Close-Up of Ladder Support Penetration (Right) on a Vertical Pressure Vessel.

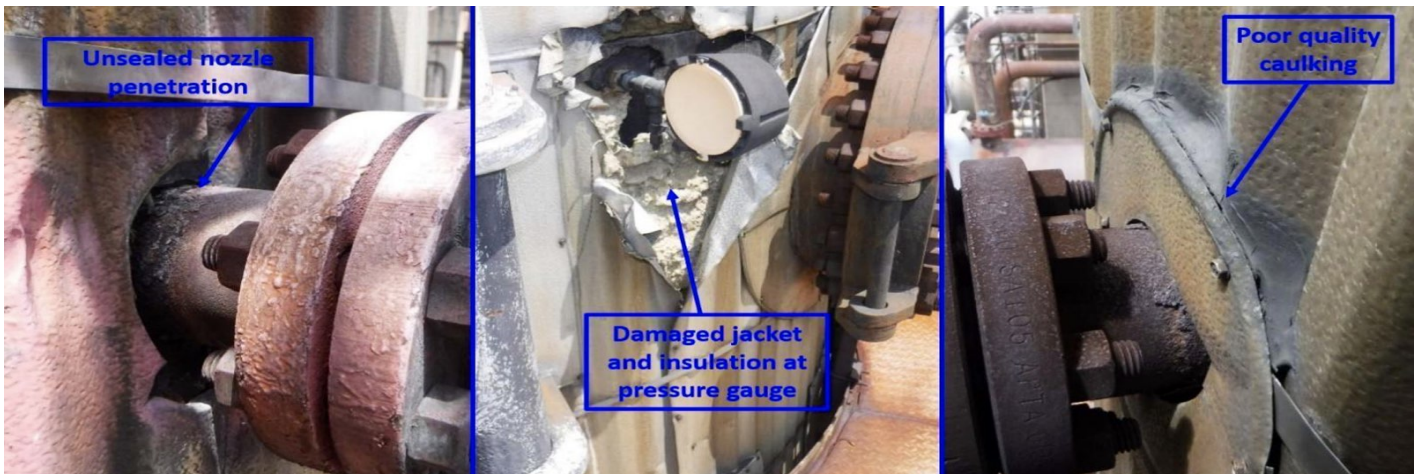
Figure 16. Additional Examples of Improper Insulation System Design at Nozzle and Instrumentation Penetrations.

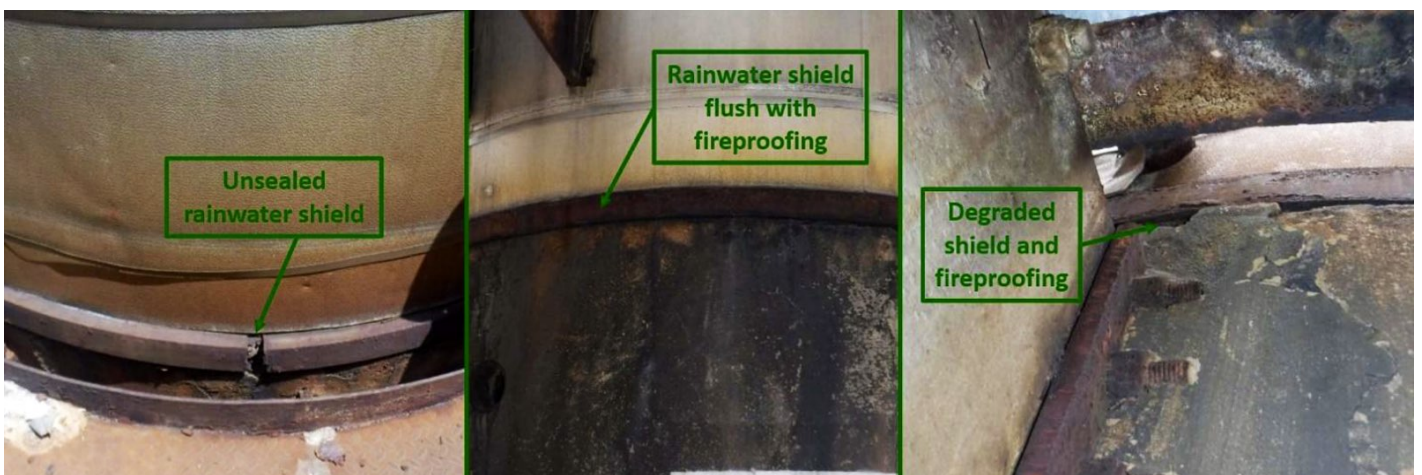
Figure 17. Examples of Poor Design Details, Installation, and Maintenance Practices Near Rainwater Shield at Support Skirt Fireproofing-to-Shell Insulation Junction.
